LANDSLIDES AND RELATED FEATURES

OF THE SPENCER, TENN. QUADRANGLE

by
Roger E. Thomas
1981

U.S. Geological Survey
OPEN FILE MAP 81-1318 (F-5)

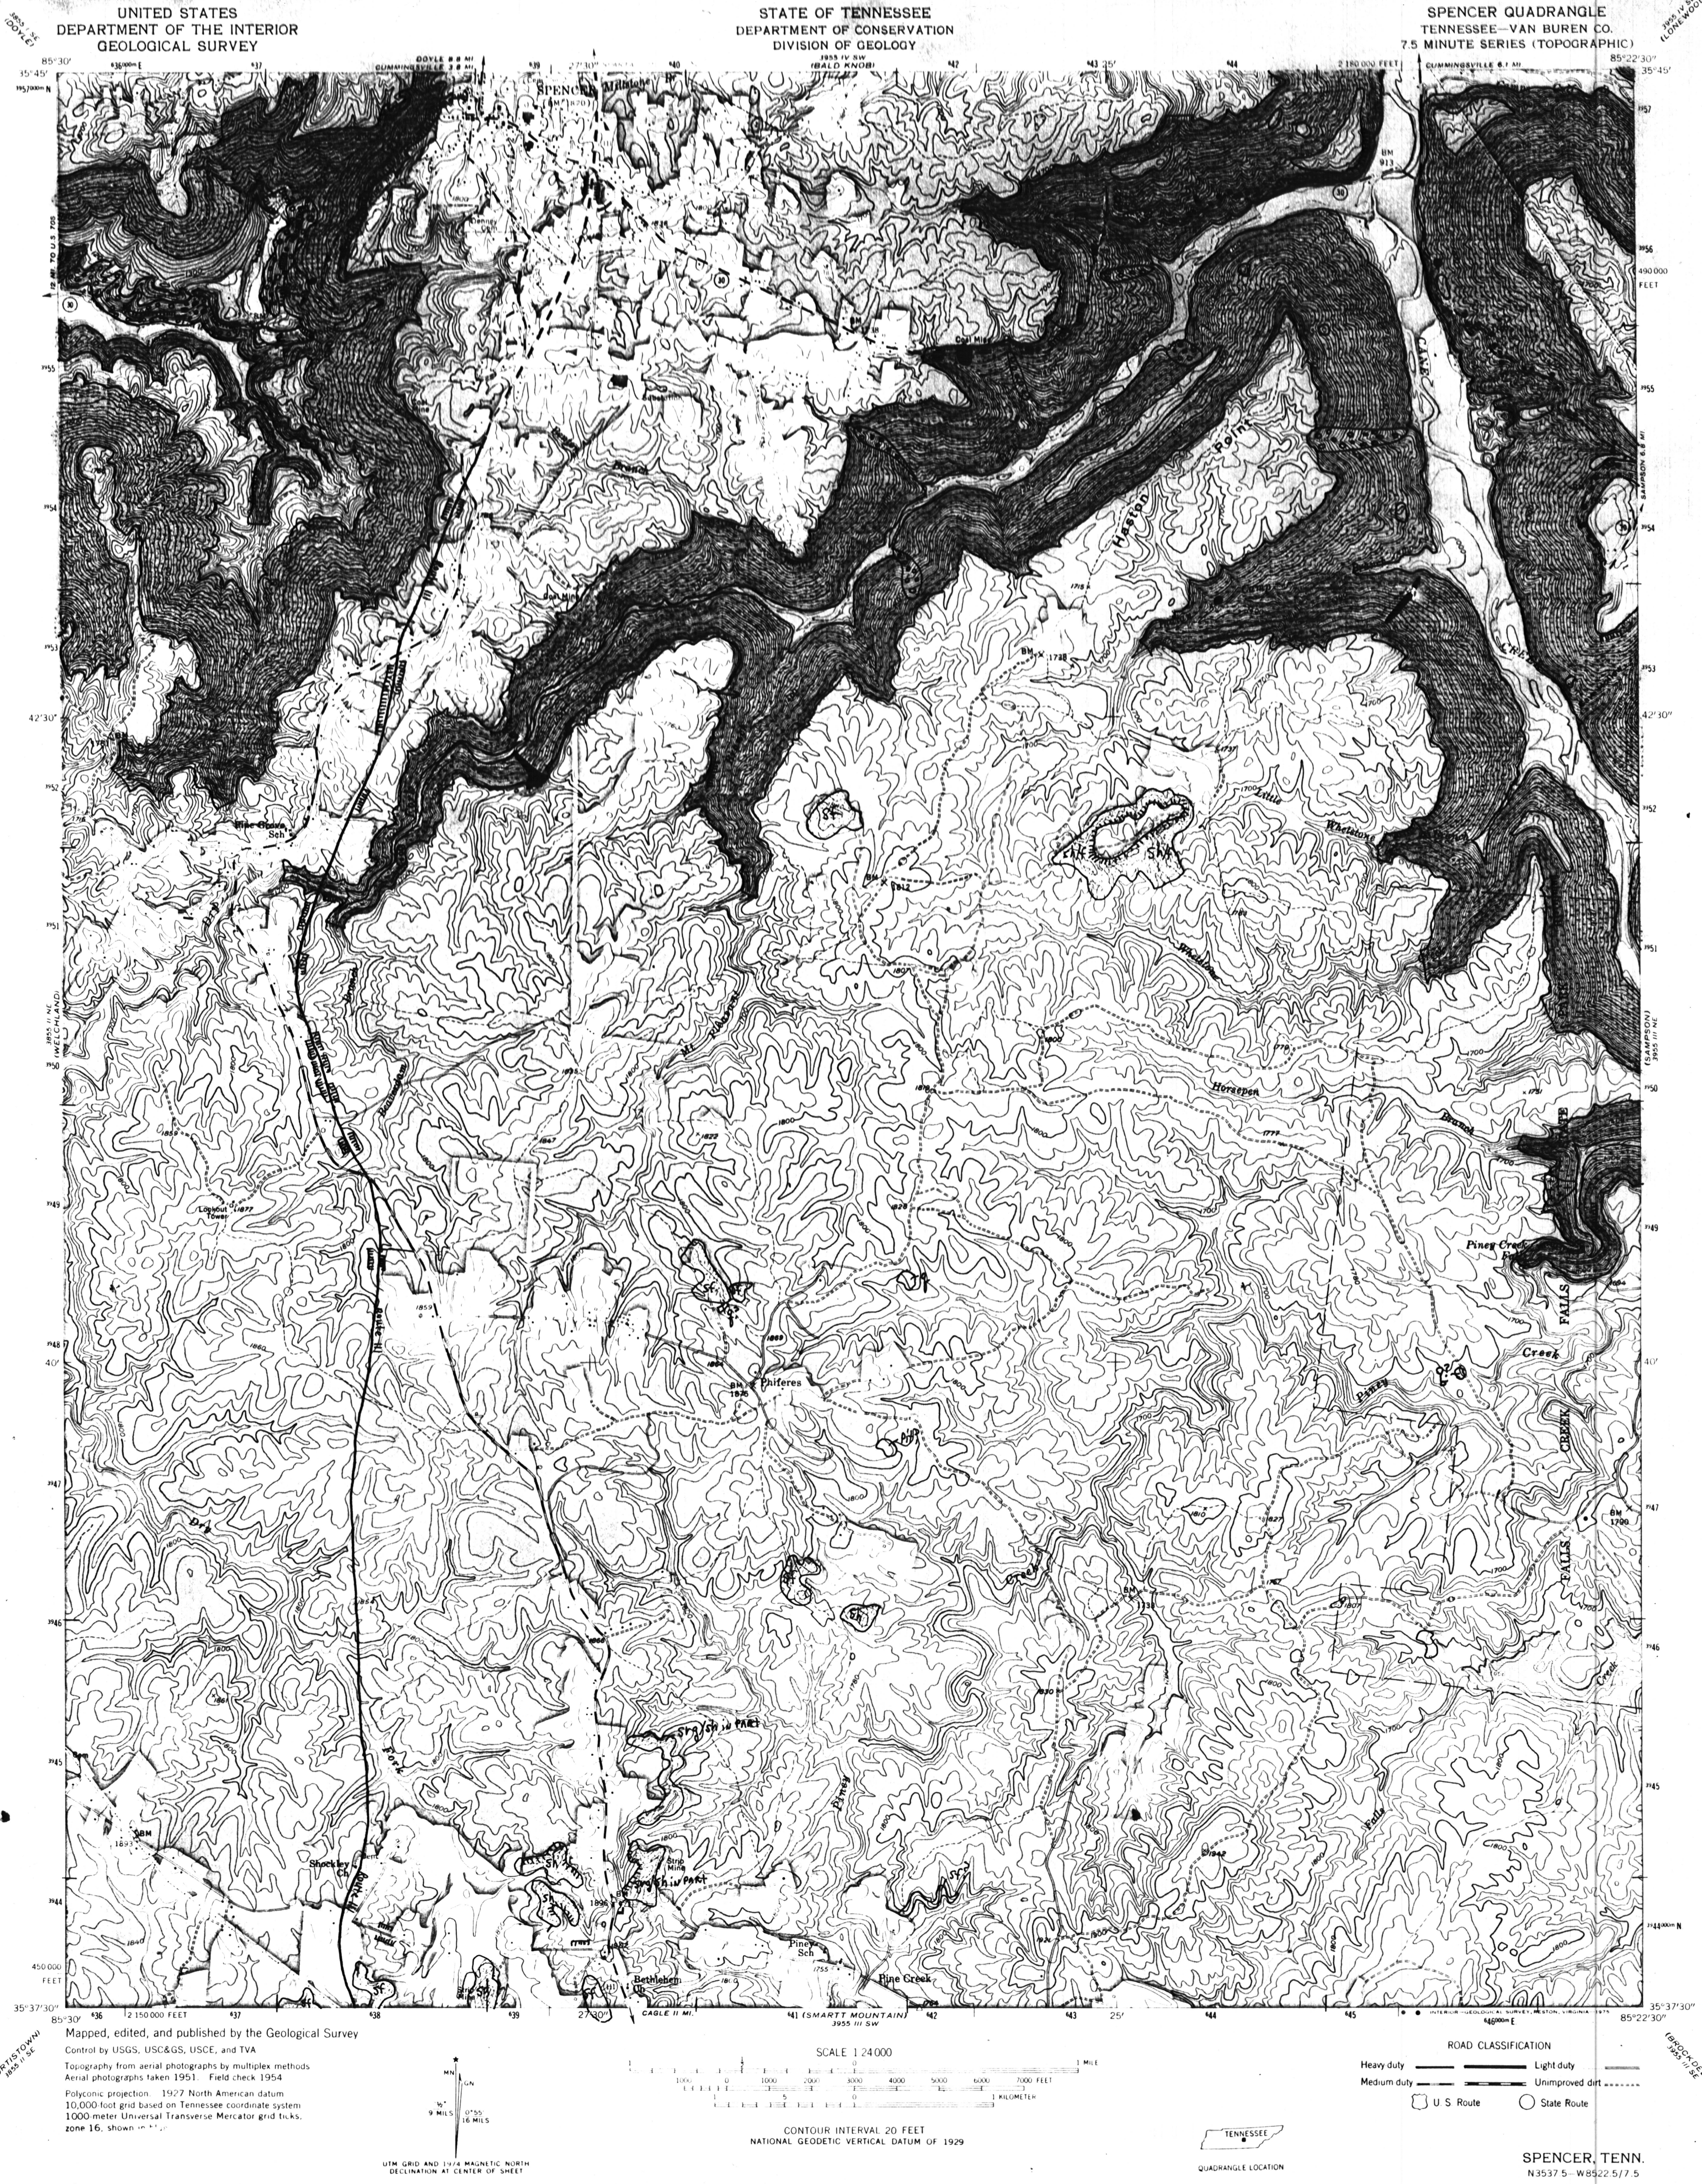
Landslides and related features interpreted from aerial photographs:
1:79,000 (Black and White) 1976
1:40,000 (Black and White) 1979

Photointerpretation and field check 1981

ACTIVE OR RECENTLY ACTIVE LANDSLIDE
Complex landslide composed of earthflow, debris slide, earth and rock slump. Identified from historical records, and from scars, debris and other field evidence. Ground extremely unstable; sliding accelerated by excavation, loading and changes in drainage conditions. May include areas with several active slides too small to be shown separately. Questioned where doubtful.

OLD LANDSLIDE
Area of extensive hummocky ground caused by earthflow and earth and rock slump. Lacks clear evidence of active sliding. Relatively stable in natural, undisturbed state, generally not affected by small structures properly sited in areas away from the edge of the toe; can be reactivated by extensive, rapid excavation, loading, and changes in ground water and surface water conditions. Area of old landslide probably includes recent ones not identified from field evidence or otherwise documented. Upslope boundary of landslide generally defined by modified scarp, but downslope (toe) may be gradational and not well defined. Questioned where doubtful.

COMBINATION LANDSLIDE
Area of recent and old slides in which individual slides are not identified.

COLLUVIAL SLOPE
Valley wall along major streams with slope as steep as 40 (85%); stony, clayey silt soil up to 50 ft. (15 m) thick; commonly buttressed by a terrace or bench at the toe of the slope; very susceptible to sliding by cutting of toe area, removal of terrace or bench, and overloading; slide commonly activated without apparent cause.

COLLUVIAL SLOPES WITH LANDSLIDES
Landslides too small or obscure to map individually.

AREAS SUSCEPTIBLE TO DEBRIS FLOWS AND DEBRIS AVALANCHES
Primarily shallow, narrow ravines and chutes with accumulation of stony colluvium generally 10 ft. (3 m) or less in thickness; susceptible to rapid movement during intense rainfall. Most ravines and chutes designated show evidence of former debris flows and avalanches.

AREAS SUSCEPTIBLE TO ROCKFALL
Steep, locally vertical, natural and man-made slopes and cliffs, 15 ft. (4.5 m) or more high; formed dominantly of sandstone, limestone, sandy shale, mudstone and claystone. Interbedded mudstone, claystone and shale weather rapidly leaving sandstone and limestone rock faces unsupported.

SOIL AND ROCK SUSCEPTIBLE TO LANDSLIDING
Soil and rock similar to that involved in landslides elsewhere in map area; primarily areas underlain by claystone, mudstone and shale associated with other rock types. Rock weathers rapidly on exposure forming clayey soil highly susceptible to sliding. Includes coves (U-shaped, shallow valleys) containing thick layers of clayey soil that are very susceptible to sliding where excavation breaks continuity of slope and where overloaded by artificial fill.

AREAS LEAST PRONE TO LANDSLIDES
Map areas in which no patterns or symbols are shown; primarily valley floors, ridge tops and broad benches; modification by excavation and fill may lead to local landslides.
